Manhole Inspection Summary

Manhole # S15I__002MH

Insp Date: **2/26/08 12:52 PM**

Location Address: **2557 boyd st**

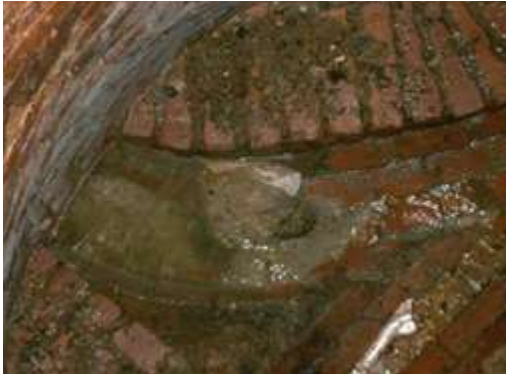
Defect 4

Condition: ☐ Sound ☐ Cracked ☐ Root Intrusion ☐ Deteriorated ☐ Leaks ☒ **Debris**

debris in channel by I9 pipe

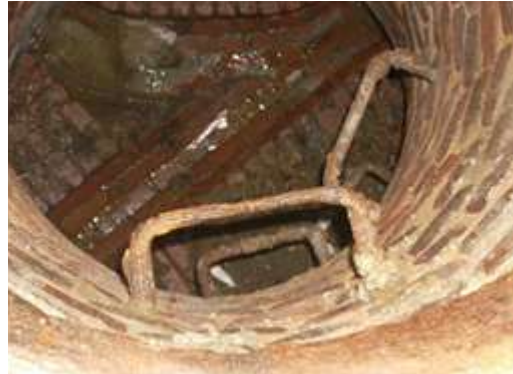
Defect 3

Count: **5** Missing: **0** ☒ **Corroded**

corroded step

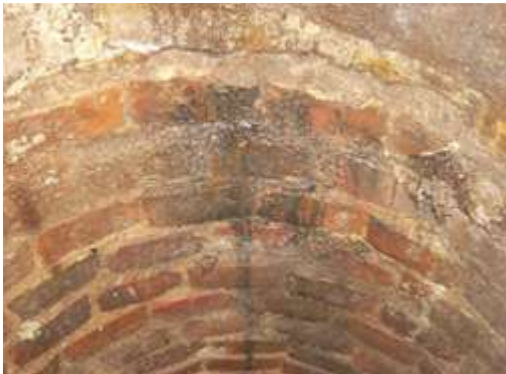
Defect 2

Infiltration: ☐ None ☒ **Joint** ☐ Cracks ☐ Mortar ☐ Roots ☐ Wall

infiltration @ chimney joint

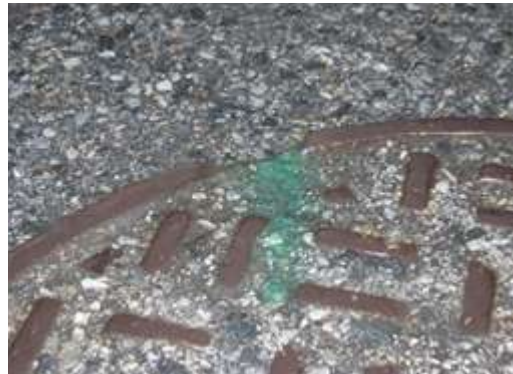
Defect 1

Condition: **Worn**

worn cover

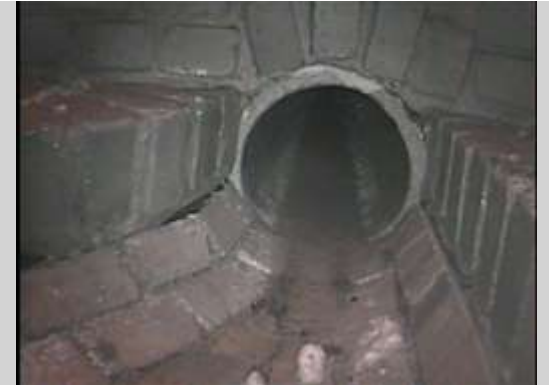
12 O'Clock Outflow

8 in. Circular Gravity Sewer
Pipe Out @ 12 O'Clock

Pipe Height: **8.4** (in.) Rod and Bar (Angled)
Pipe Material: **Clay** ☐ Pipe Lined
Invert Depth: **9.20** (ft.) Flow Characteristics: **Slow**
Deposits: ☒ None ☐ Mud ☐ Sludge ☐ **Debris** ☐ Grease
Silt Depth: **0** (in.) Deposits Extent:
Infiltration: **None** Pipe Seal Cond: **Sound**

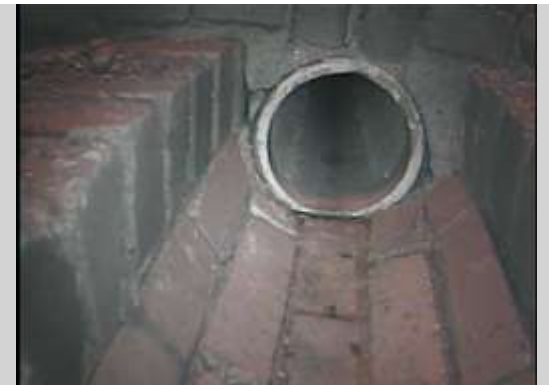
6 O'Clock Inflow

6 in. Circular Gravity Sewer
Pipe In @ 6 O'Clock

Pipe Height: **6** (in.) Rod and Bar (Angled)
Pipe Material: **Clay** ☐ Pipe Lined
Invert Depth: **8.92** (ft.) Flow Characteristics: **Slow**
Deposits: ☒ None ☐ Mud ☐ Sludge ☐ **Debris** ☐ Grease
Silt Depth: **0** (in.) Deposits Extent:
Infiltration: **None** Pipe Seal Cond: **Sound**

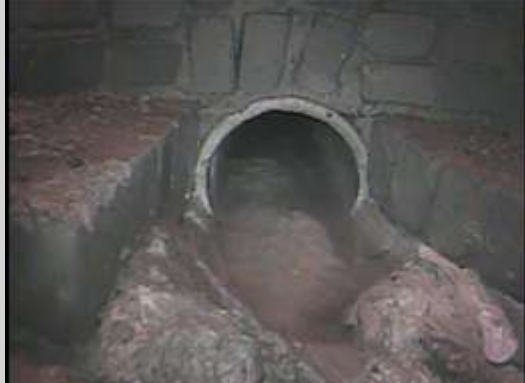
9 O'Clock Inflow

8 in. Circular Gravity Sewer

Pipe In @ 9 O'Clock

Deposits: ☐ None ☐ Mud ☐ Sludge ☒ **Debris** ☐ Grease

Silt Depth: **2** (in.) Deposits Extent: **Medium**
